## Access problems at Oakfield Road, Davenport

**Report by Charlie Hulme. March 2016**

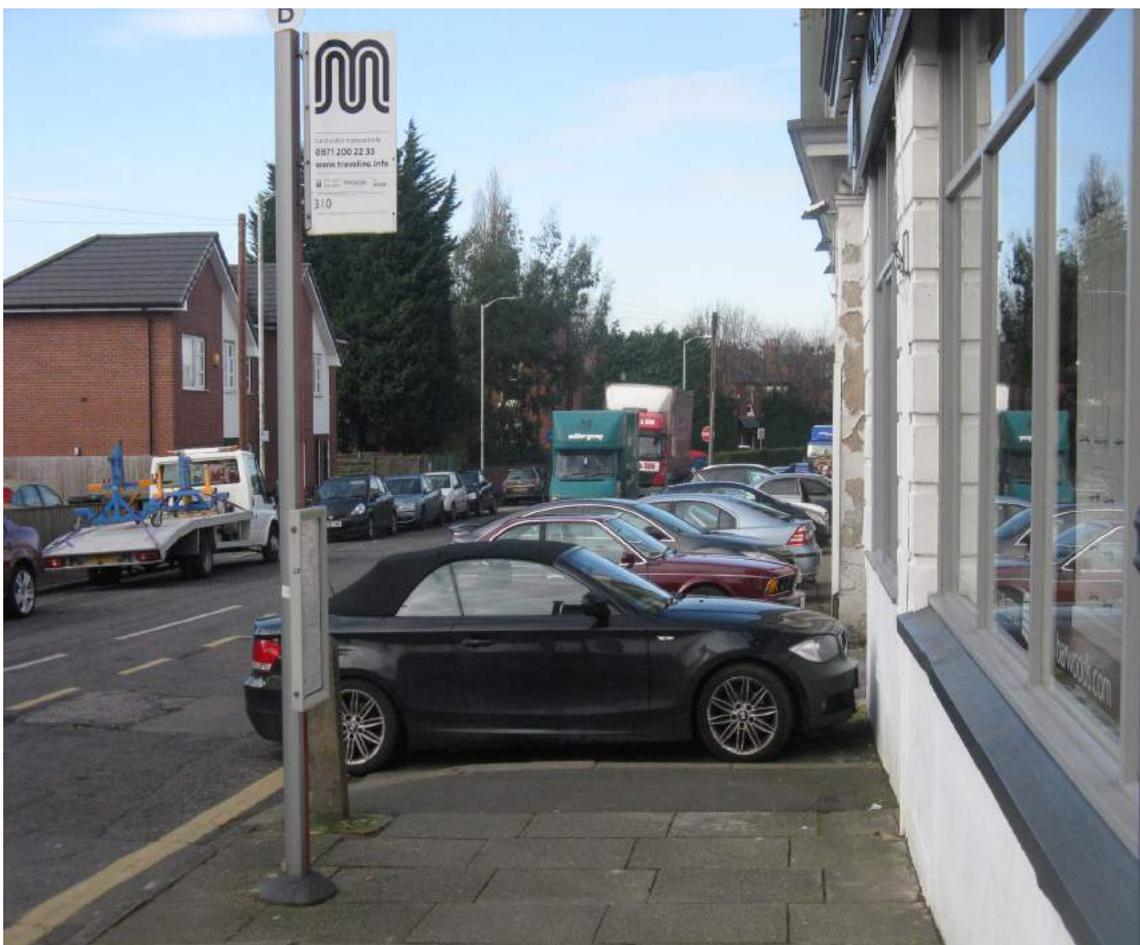
A photograph of Oakfield Road taken at 9.30am on Thursday 25 February 2016. Pedestrian access on the north side is impossible, and the bus stop obstructed. Large vehicles loading and unloading.

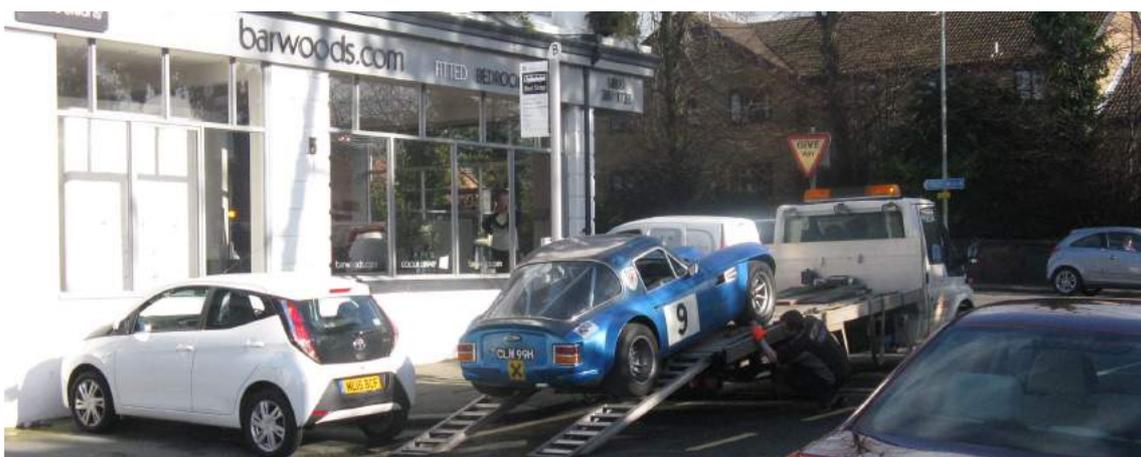
11 February 2016, 12:35: a novel use for a bus stop.

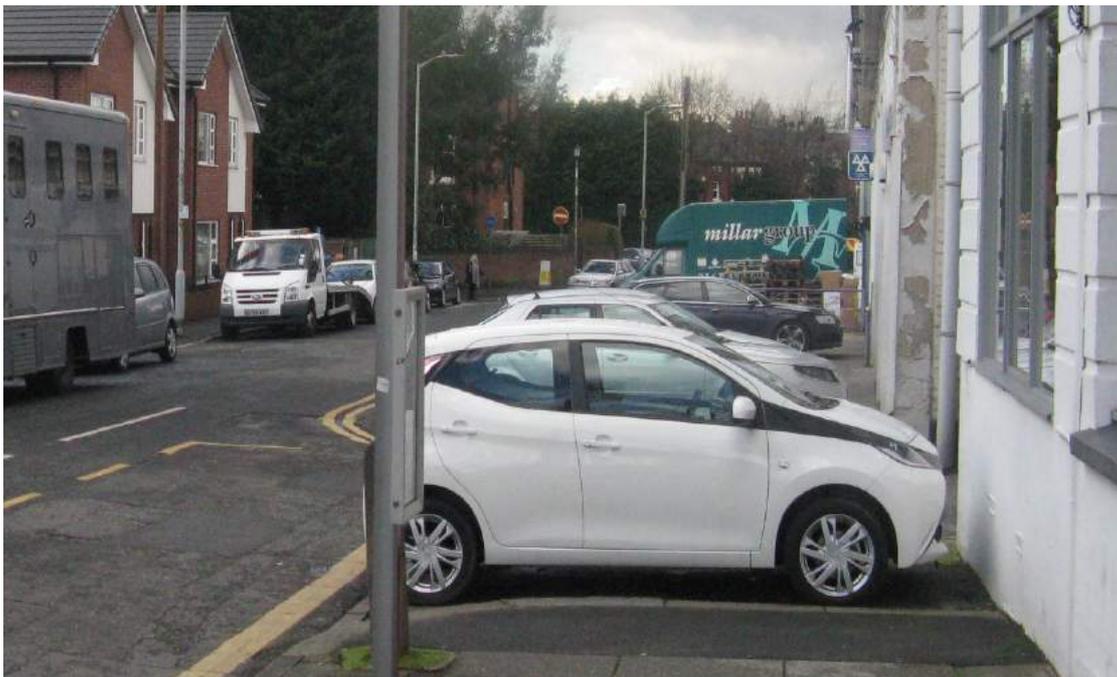
From the point of view of wheelchair and mobility scooter users there is a further problem which has never been solved. There is a high kerb adjacent to the bus stop, originally part of a rear access to the Bramhall Lane buildings before the one on the corner was extended. As the picture shows, the area is routinely used as a parking space. The window to the right of the white car belongs to the extension, once a small antique shop.

It is, of course, true that the businesses in the garages are still thriving, helping the economy of the area and providing employment opportunities, and it seems there is no hope of keeping the area clear for pedestrians. At the very least, however, action is needed to prevent obstruction of the bus stop.

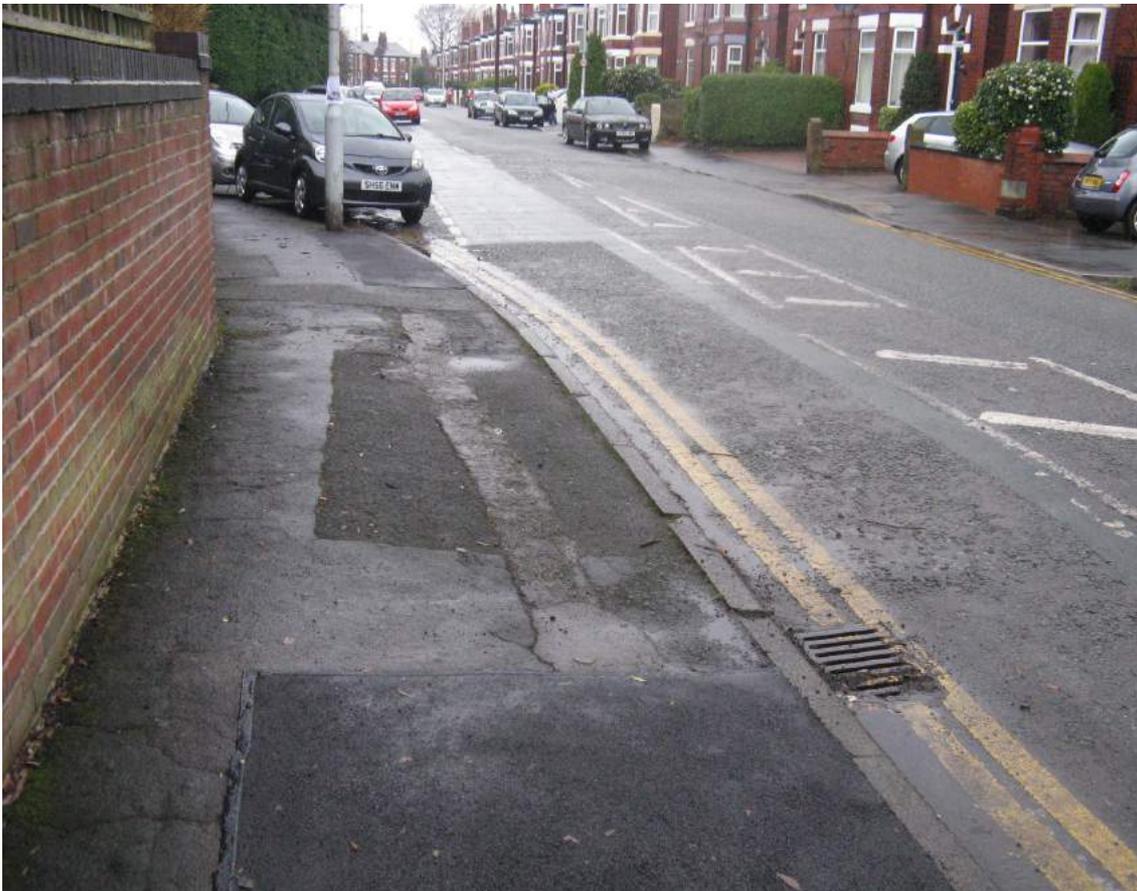
For many years, perhaps since the petrol-filling station which once stood there was abandoned, the pavement surface on the south side of Oakfield Road, between Bramhall Lane and Beechfield Road had been in poor condition with broken-up and rough tarmac. Recently there has been some patching-up of the surface, but what is really needed is a complete re-laying of the whole length.

This view from 17 February 2016 shows two new patches, in the foreground and by the lamp post, with untreated areas between. Note also the cars parking on the pavement beyond the double-yellow lines.

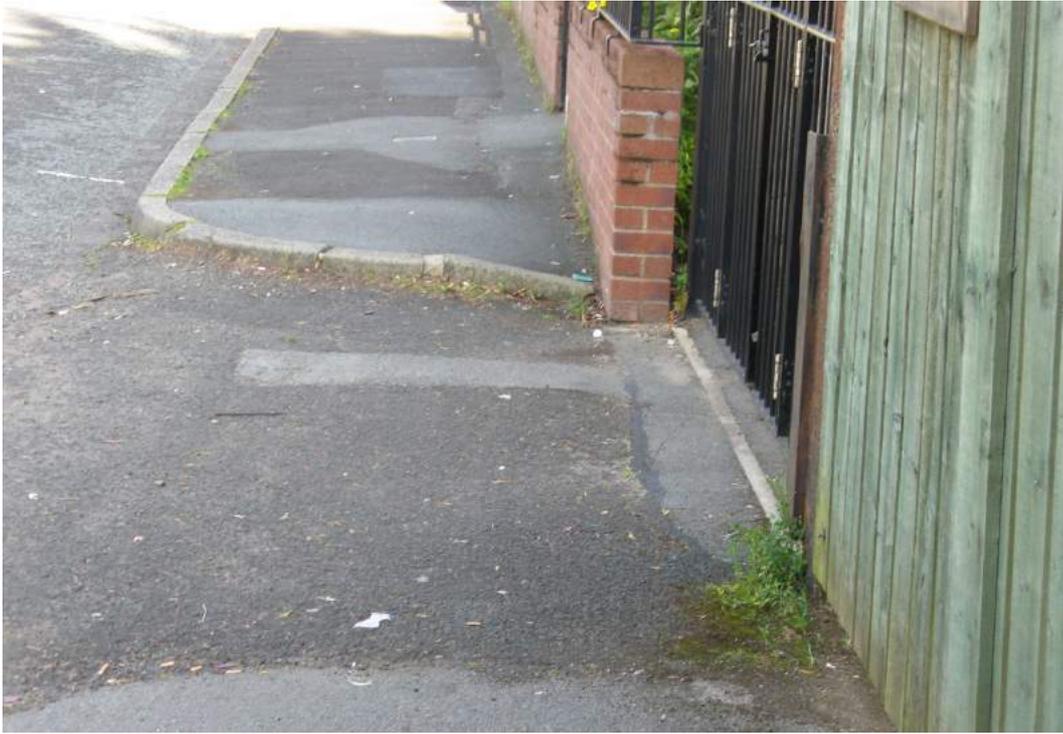
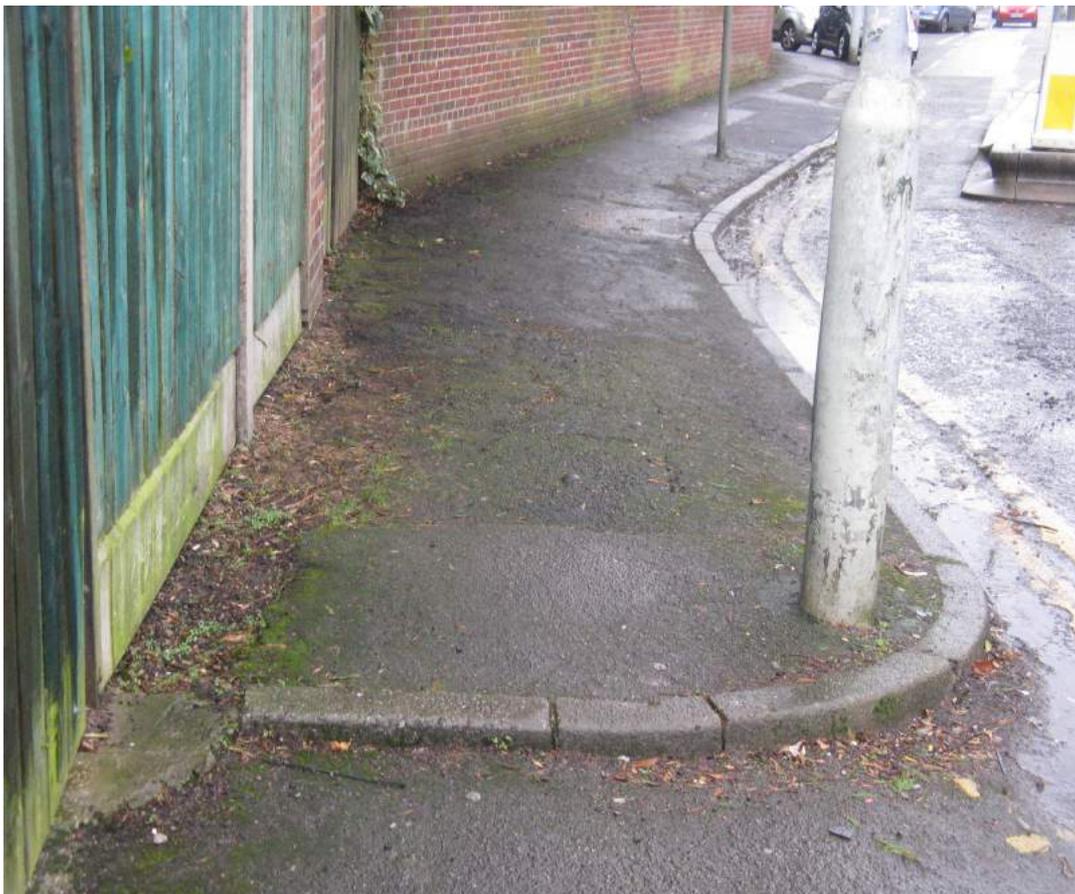
A major obstacle facing wheelchairs, mobility scooters and people with pushchairs or shopping trolleys is the kerb round the gateway adjacent to No.3 Oakfield Road. Clearly this needs to be provided with dropped kerbs each side. These two views show both sides. Again, very rough pavement in evidence.
